Ultra Home Inspections LLC

General Information

BUILDING ADDRESS: 123 Main St.
CITY: Mall City
STATE: Michigan
ZIP CODE: 12346
INSPECTION DESCRIPTION: Single-family ranch style one level home
SQUARE FOOTAGE: 1500

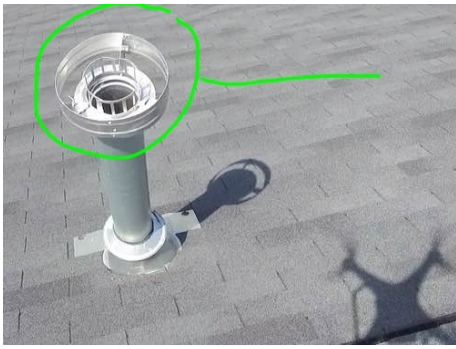
CHIMNEY Poor

The vent is missing the flue cap. Recommend repair / replacement by a qualified contractor or handyman.

The Flue cap is missing on the vent. This was also noted with a picture in the roofing section.

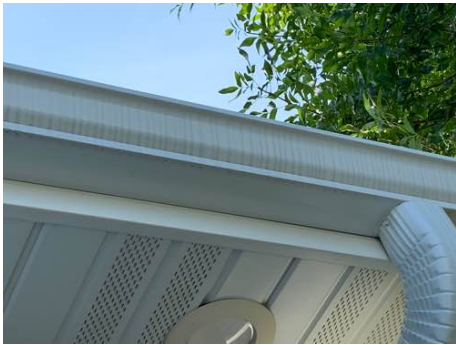
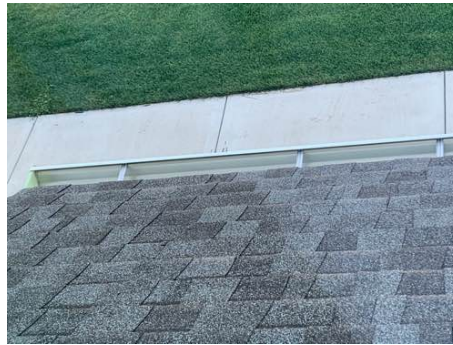
GUTTERS AND DRAINAGE Fair

All of the gutters were cleared at the time of the inspection, however they are showing stains from being clogged in the past. Recommend installing covers to keep out debris.

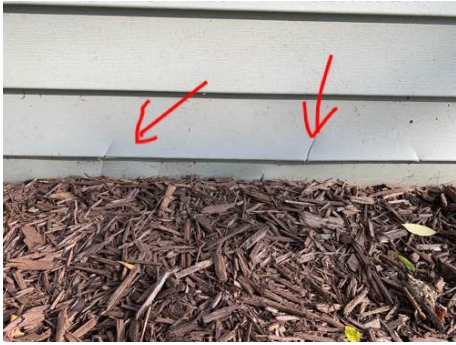
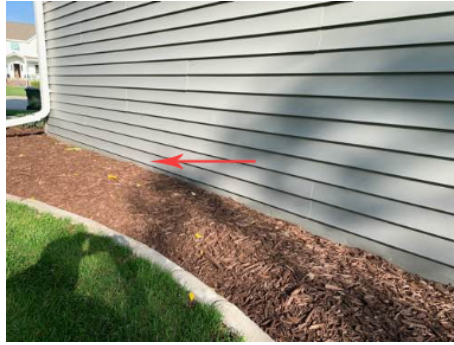
SIDING CONDITION Inspected

The siding is in good condition all around the home with the exception of some minor damage on the north east side. Recommend further evaluation by a qualified siding contractor.

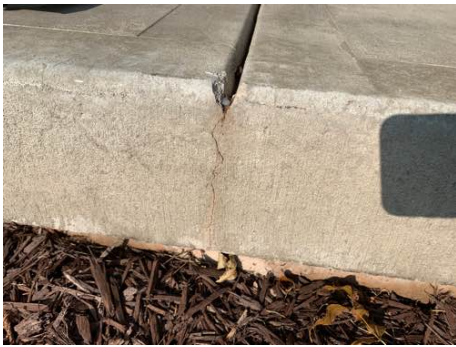
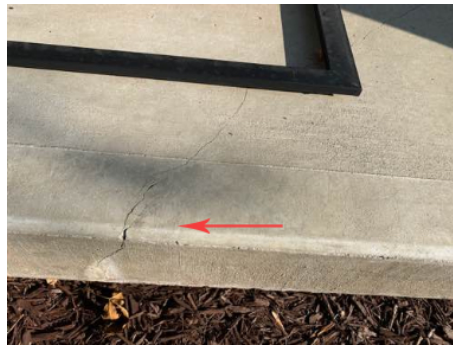
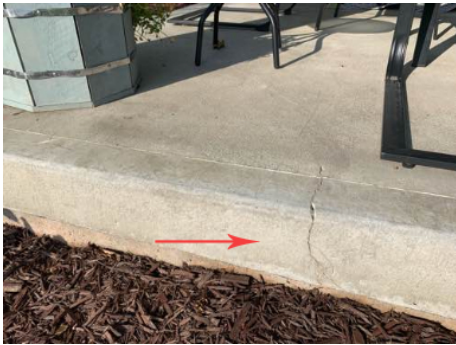
STOOP / PORCH Fair

Concrete shrinkage cracks exist on back porch. These cracks are normal and should not be an issue, however I recommend you monitor these in the future for any possible movement.

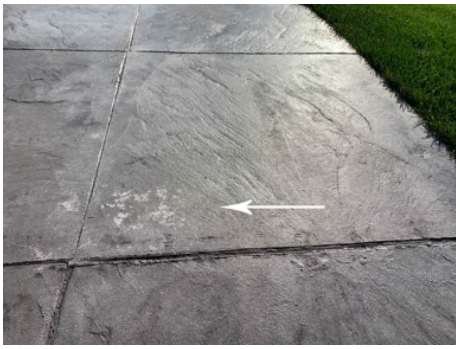
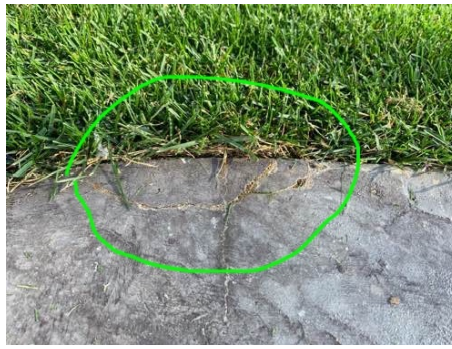
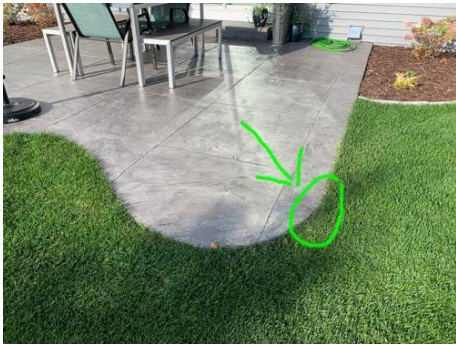
PATIO Inspected

I recommend sealing the stamped concrete patio each year to prevent color loss. There is also a repaired crack on the edge of the patio. I put pressure on it to test it and it appears to be holding up just fine.

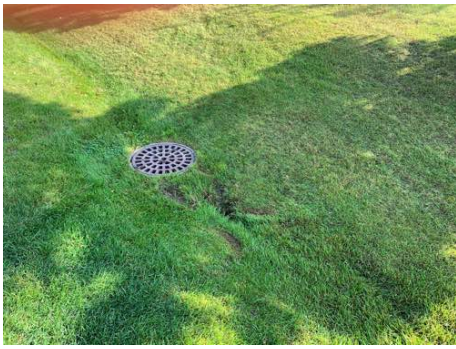
SURFACE DRAINAGE Satisfactory

All water drains nicely to this storm drain in the backyard. I recommend you keep this cleared especially in the spring and fall.

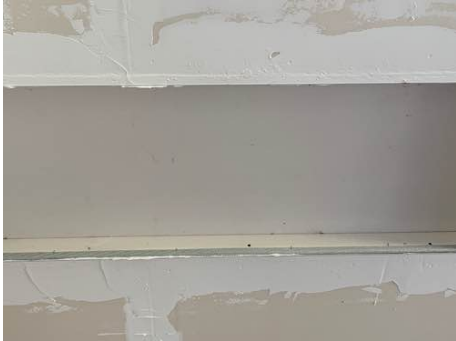
ACCESS Poor

The attic access was nailed shut. Unable to access without damaging the home. Recommend requesting access from seller for further evaluation in the future.

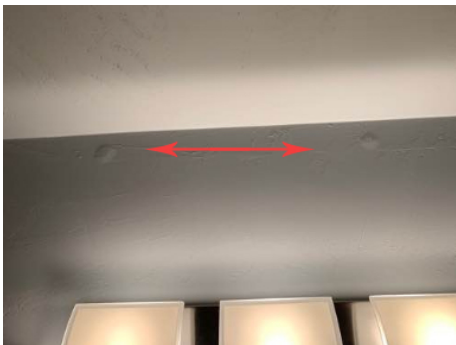
WALLS Inspected

I noticed several nail pops are present in the drywall. At this time it is only a cosmetic issue. I recommend monitoring this in the future.

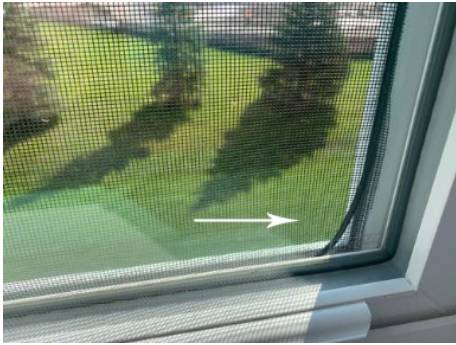
WINDOWS Poor

One screen is damaged in the master bedroom window. Recommend repair / replacement by a homeowner or handyman.

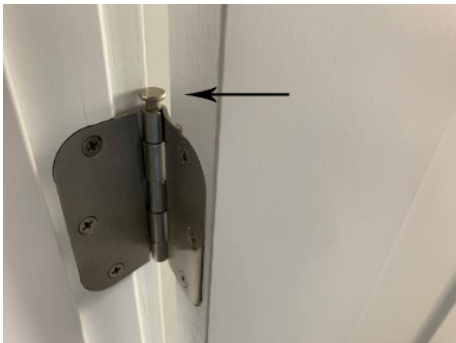
DOORS Fair

There is a squeaky hinge on the north side bedroom door. Recommend greasing the hinge.

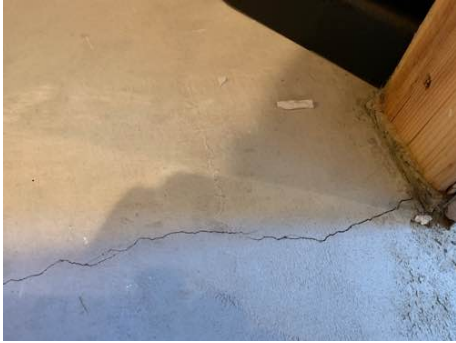
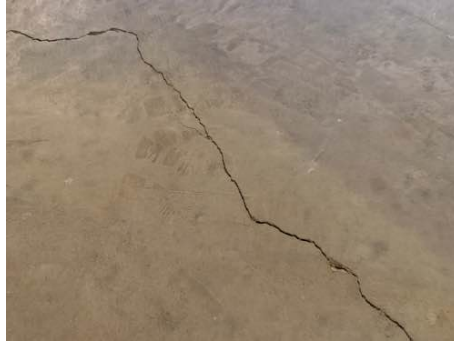
SLAB Satisfactory

Two normal shrinkage cracks were noticed. This is not a major concern however I do recommend you monitor this in the future for any possible movement. Both cracks are located within 3 feet of the bottom of the stairs to the basement.

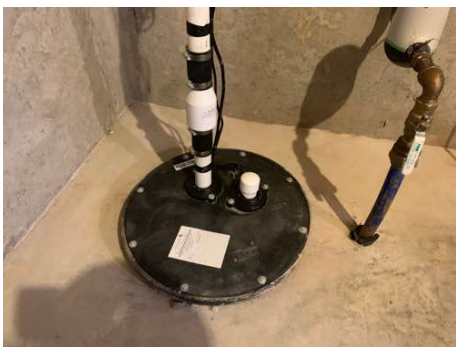
SUMP PUMP & PIT Satisfactory

The cover was installed to keep radon out of the home. I did hear the sump pump turn on one time during the inspection.

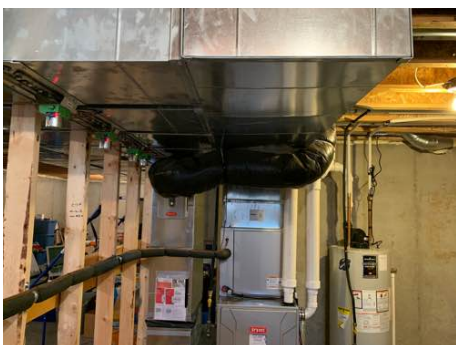
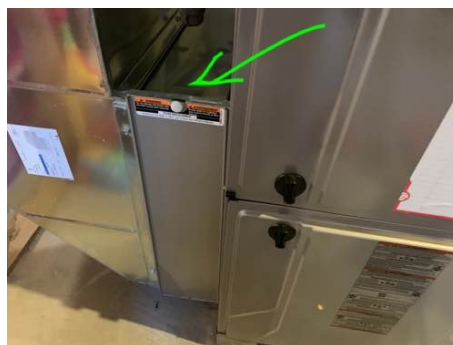
HEATING SYSTEM OPERATION Satisfactory

The forced air unit operated just fine at the time of the inspection and is only two years old. Recommend changing air filters regularly and annual servicing by a qualified hvac technician.
